2007 Final Summary of the bed wood finishes testing

In the [Summer of 2005](#) we began a test of 10 different wood finishes. The purpose was to get comparative test results of how well the finishes would last when left outdoors. We mounted 30 samples of bed wood boards with ten different finishes in a fixture that held them in a slightly inclined position, and left them outdoors to see when the finishes would fail or deteriorate. The samples are held in the fixture with unpolished stainless bedstrips and stainless bolts much the way bed wood is held in a truck bed.

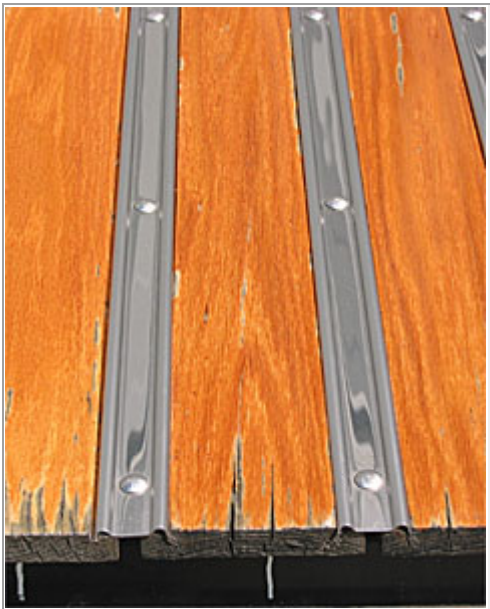
<p>1. Oak boards, coated with one brushed heavy coat of CPES epoxy and three sprayed coats of Aliphatic Urethane. The Aliphatic Urethane was applied before the CPES was fully cured for best adhesion as recommended by the epoxy manufacturer, Smith & Co.</p>	<p>The ends of the boards developed several cracks and turned black.</p> <p>The color of the boards became noticeably darker, possibly indicating UV damage.</p> <p>Relatively few cracks in the center areas of the boards.</p>	<p>The adhesion appears to be very good. The topcoat only began to separate from the epoxy in the last couple months.</p> <p>CPES is water thin and somewhat difficult to apply in a heavy coat.</p> <p>Multiple coats of the CPES epoxy would probably have given better results.</p>

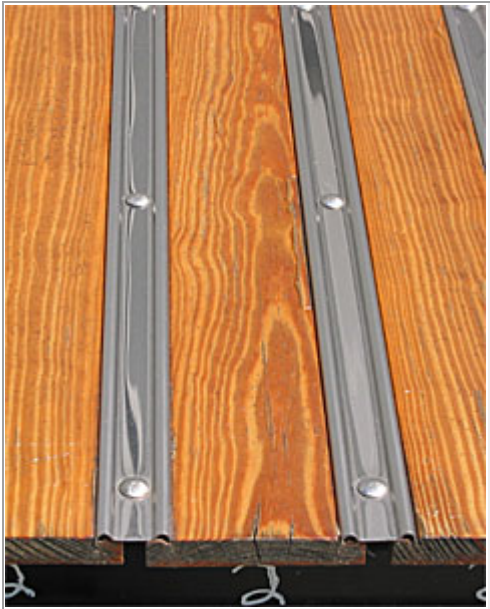
<p>2. Pine boards, coated with one brushed heavy coat of CPES epoxy and 3 sprayed coats of Minwax Helmsman Spar Urethane. The Helmsman was applied before the CPES was fully cured for best adhesion as recommended by the epoxy Manufacturer, Smith & Co.</p>	<p>The ends of the boards developed cracks and became very black, no protection.</p> <p>The color of the boards became slightly darker during the test</p> <p>The topcoat is peeling from the epoxy.</p>	<p>Multiple coats of the CPES epoxy would probably have given better results, especially on the ends of the boards.</p>

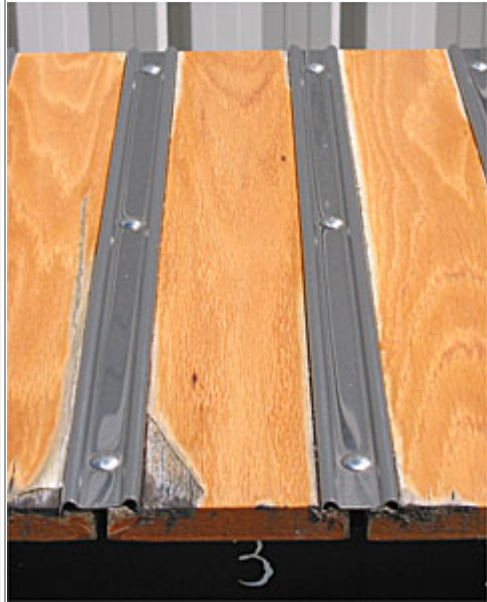
3. Oak boards, coated with two coats of RAKA epoxy, cured one month, block sanded, and topcoated with three coats of automotive clearcoat.

Extensive separation of the coats, the topcoat often coming off in sheets.

Some cracks in the ends of the boards, some deterioration of the finish in the ends.

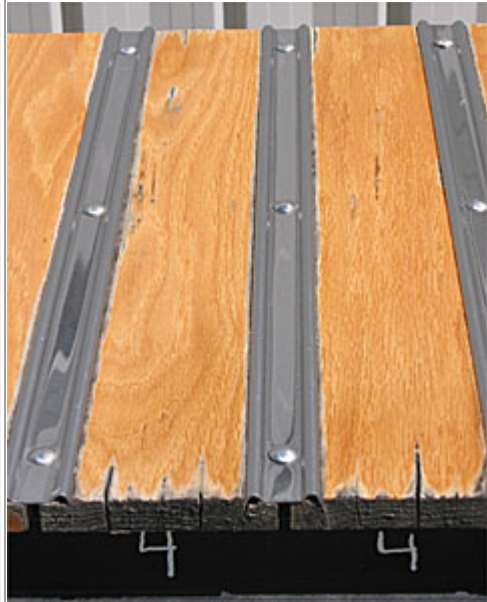
4. Oak boards, coated with one brushed heavy coat of CPES epoxy and three sprayed coats of automotive clearcoat. The clearcoat product was applied before the CPES was fully cured for best adhesion as recommended by the epoxy manufacturer, Smith & Co.

Ends of the boards have cracks and are totally deteriorated.

The topcoat is peeling, especially at the edges of the boards.

The boards were shiny but not as shiny as #3 above. The wood was not darkened during the test.

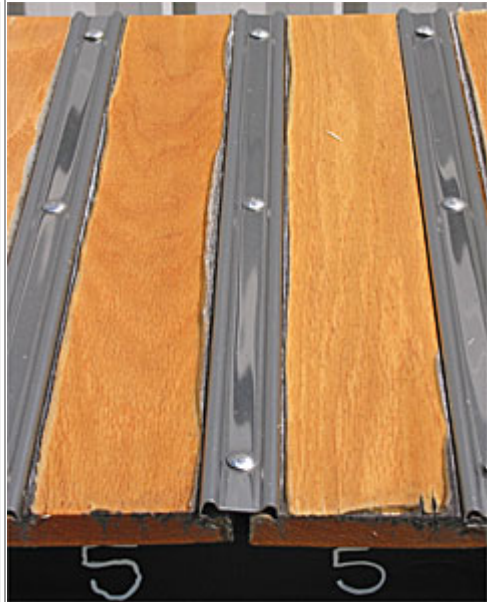
5. Oak boards, coated with two brushed coats of RAKA epoxy, cured one month, block sanded, and topcoated with three sprayed coats of Minwax Helmsman Spar Urethane.

All edges the topcoat is peeling up and separating from the epoxy.

The ends of the boards are deteriorated, not as bad as some other samples.

The center areas of the boards are not cracked.

The color has darkened somewhat since the beginning of the test.

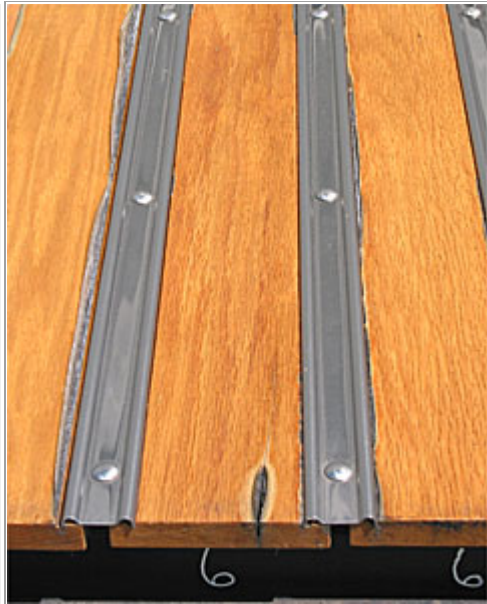
6. Oak boards, coated with three brushed coats of Pelucid three hours apart, cured 4 days, block sanded, and sprayed with three coats of Minwax Helmsman Spar Urethane.

One bad end crack in one of the boards, causing deterioration on that board

Top coats are beginning to peel away from the Pelucid along some of the edges.

No cracks in the center areas of the boards.

The color has darkened some since the beginning of the test.

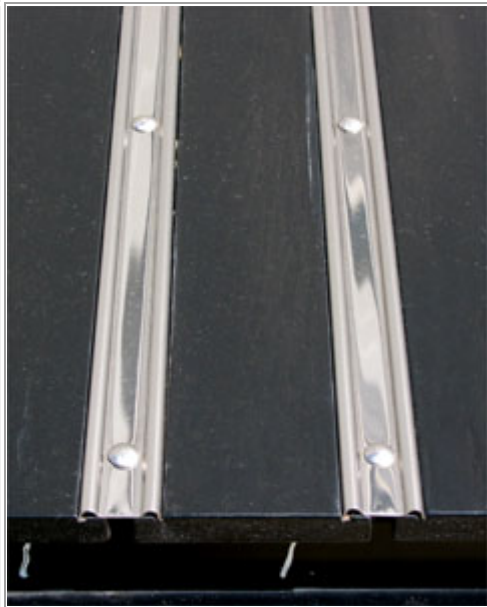
7. Oak boards, coated with three brushed coats of POR-15 Rust Preventative Paint three hours apart, then three coats brushed Behr best quality black exterior latex enamel, three hours apart.

This coating has not failed. Only slight dulling of the original gloss. No other defects.

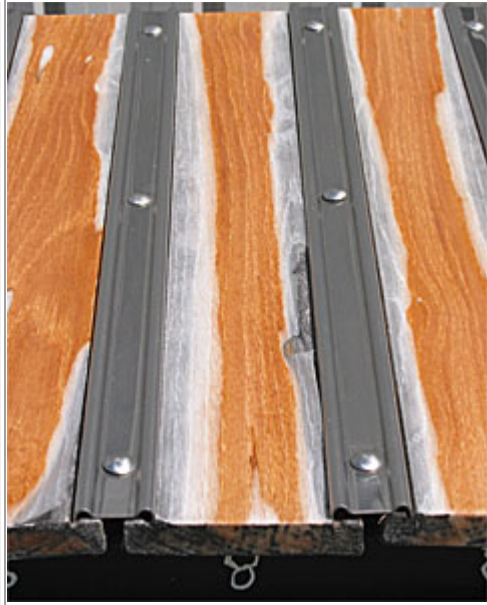
8. Oak boards, coated with one brushed coat Glisten, cured 24 hours, scuff sanded, and then three more coats of Glisten, one hour apart.

This system failed very early in the test, with only a few weeks exposure. The finish is peeling, coming loose in large sheets.

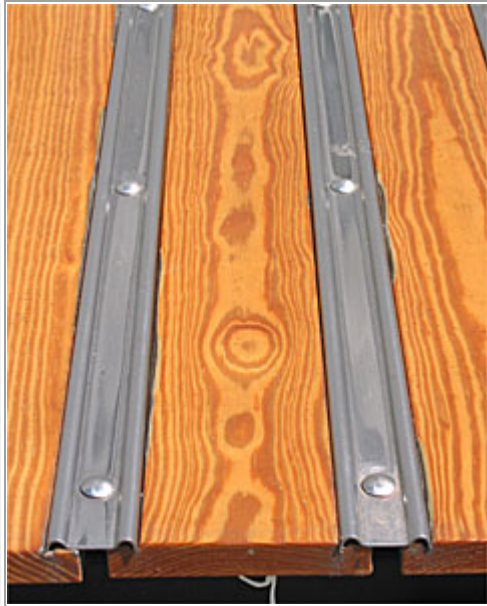
9. Pine boards, coated with three brushed coats of Pelucid three hours apart, cured 4 days, block sanded, and sprayed with three coats of Minwax Helmsman Spar Urethane.

Starting to peel in a few places along the edges of the boards. The ends of the boards look good, with no cracks or deterioration.

The color has darkened somewhat. The surface is not nearly as glossy as at the start of the test. *This sample shows the least failure of any of the clear finishes tested.*

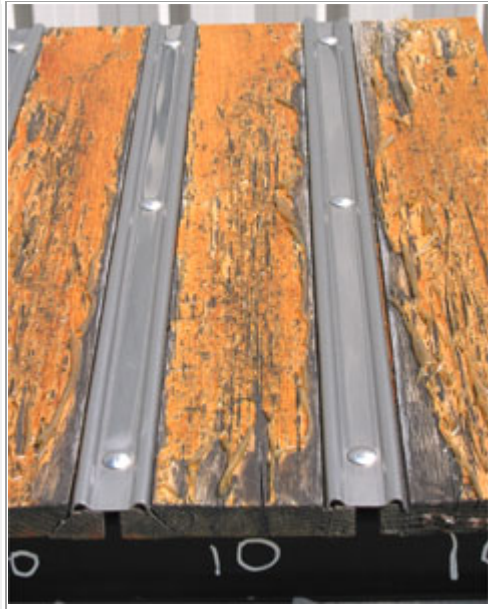
10. Oak boards, saturated with several coats of heated linseed oil until it would not absorb any more, cured three months, wiped with turpentine to remove excess dried linseed oil from the surface, and when dry, sprayed with three coats of Minwax Helmsman Spar Urethane.

Excessive cracks and peeling.
Ends of the boards have totally failed.

The finish has darkened considerably.
