Installing a 54 GM bed on a 47-53 Frame: Some options, none easy

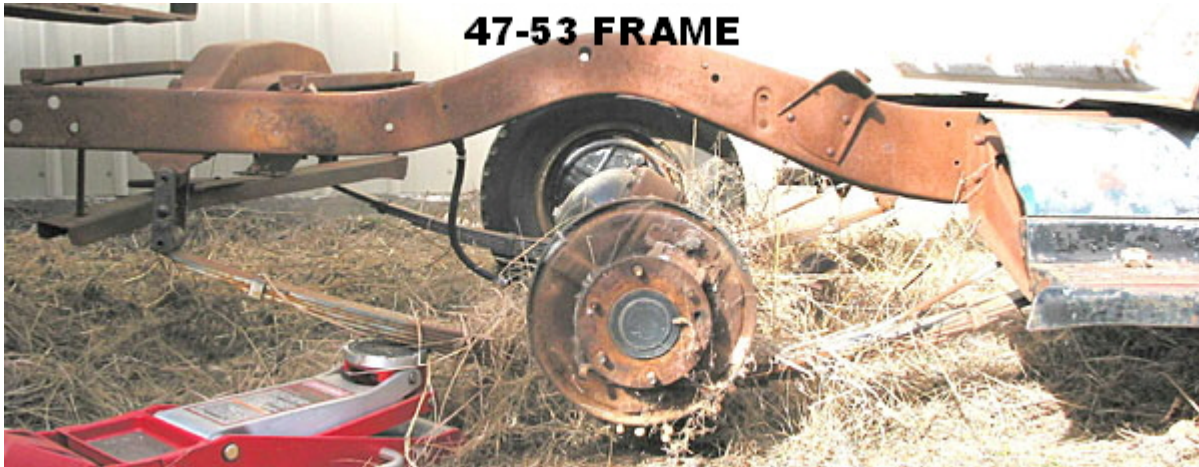
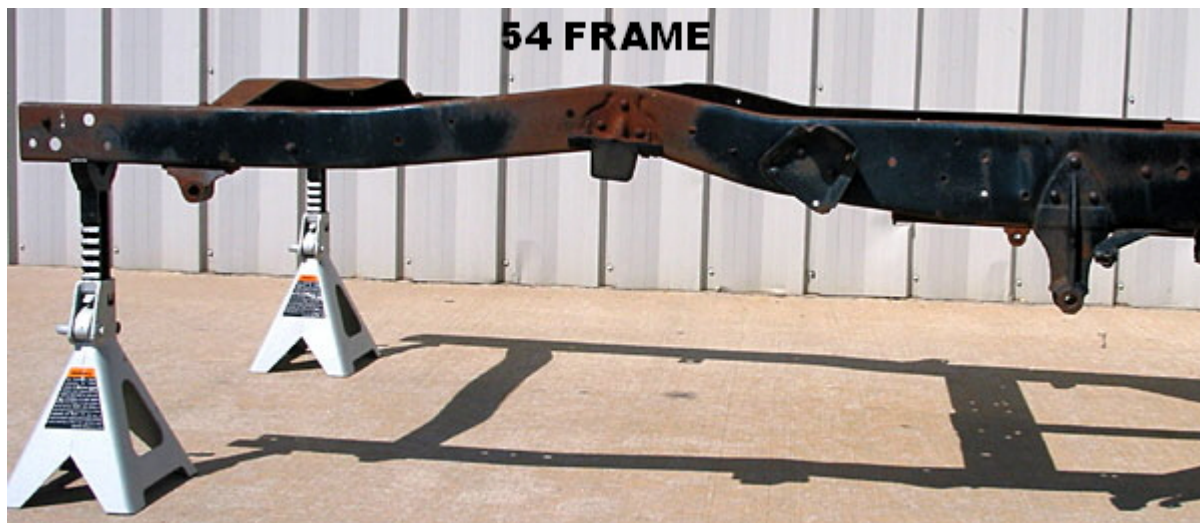
The main problem with installing a later bed on the 47-53 frame is the earlier frame has a much higher "kick up" or arch over the rear axle area. It is about 4 inches higher than the rest of the frame and the 54 frame "kick up" only rises about 2 inches. A 47-53 bed is installed on wooden blocks under the cross sills that raise the bed about 2-1/8 inches so the bottom of the wood is about 4 inches above the frame, which allows for the 4 inch kick up over the axle. The 54 bed does not use wood blocks under the cross sills so the bottom of the bed wood floor on a 54 truck is about 2-1/8 inches above the

frame. The photos show the two frames and the profile of the 54 frame is noticeably flatter than that of the 47-53 frame.

The result of all this math is that when installing the 54 bed on the earlier frame, the bed wood boards rest on the frame kick-up and the cross sills will not rest on the frame as they should. This effectively raises the bed about two inches above the desired installation height and there just is not a simple way to lower the bed to the right position without major surgery on either the frame or the bed wood.
