MAR-K

RESTORATION AND CUSTOM PICKUP PARTS

INSTALLATION INSTRUCTIONS FOR 58-66 GM WHEEL TUB REPAIR FLANGE

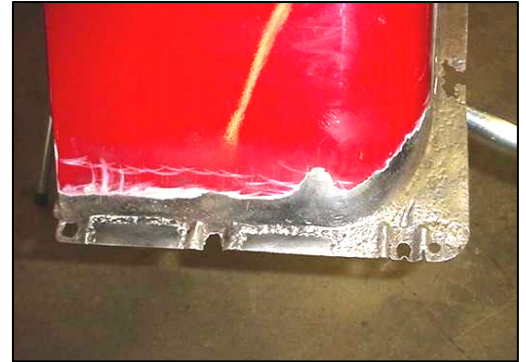
This instruction covers the repair of the wheel tub flange where it meets the wood floor in 1958 to 1966 GM trucks with the Fleetside bed. These areas are prone to rusting because of the wood holding moisture and the steel flange resting on the wood floor. This repair flange may be used to completely replace this flange or be used in pieces to repair this area. The wheel tub pictured at the right is an extreme case of deterioration caused by rust.

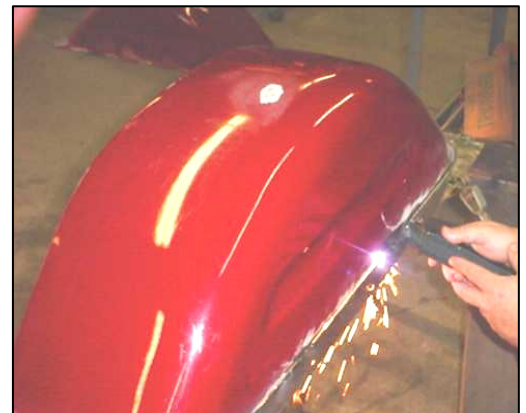
3. Remove the repair flange. Using a plasma cutter or a cut-off wheel, remove the damaged area of the wheel tub flange. Cut on the scrap side of the scribe line or marks made in the previous step. This wheel tub was rusted enough to need the complete flange replaced.

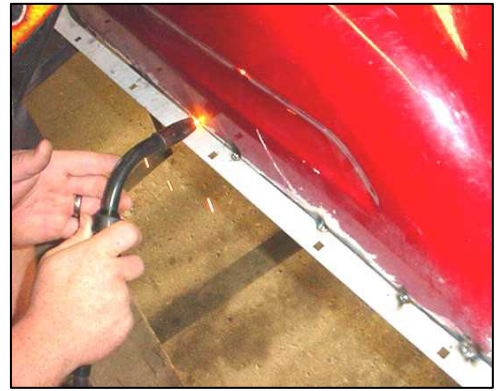
4. Fit the repair flange to the wheel tub. You may need to dress up the wheel tub where the damaged flange was removed. When the fit is good, tack weld the repair flange to the wheel tub in several places.

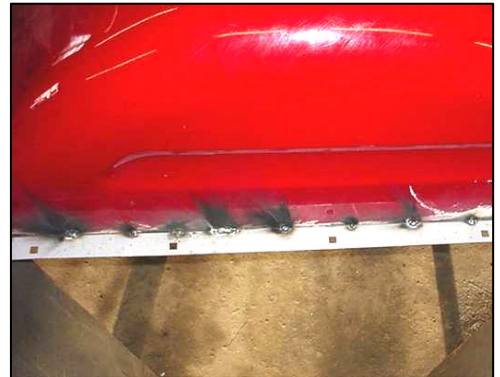
5. Continue welding the repair flange to the wheel tub. Use small welds and move around the wheel tub so that the repair flange does not warp from weld heat. If you are repairing both wheel tub flanges, alternate between them to allow the welds to cool.

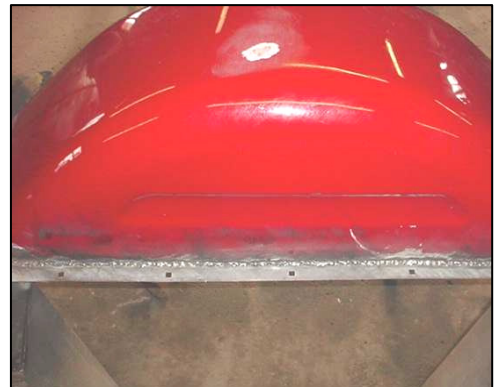
6. Weld between the other welds until the entire seam is welded. Remember to allow the welds to cool so that warping does not occur. Check on the underside of the wheel tub for proper penetration of the welds.

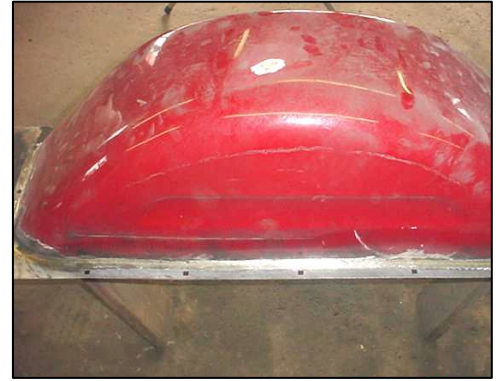
7. Grind the welds smooth on both top and the underside of the wheel tub. Work slowly and avoid building up too much heat. Be extra careful around the hump areas where the bed strips go. A grinder could easily damage this area.

The repair flange should now be an integral part of the wheel tub. Sand these areas; primer and paint as desired
